NBSIR 82-2465 (A)

# Investigation of the Kansas City Hyatt Regency Walkways Collapse

February 1982

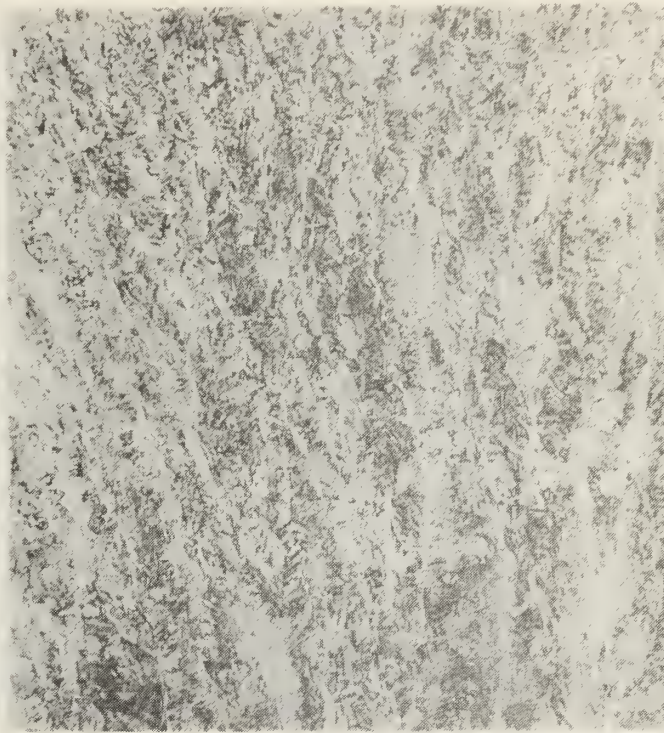
A representative region of the weld metal appears in figure A7.4.1-3. The microstructure consists primarily of bainite. Microhardness values based on 17 measurements average 205 HK<sub>500</sub> (90.9 HRB) and range from 195 to 228 HK<sub>500</sub> (88.5 to 95.5 HRB).

Figure A7.4.1-3 Microstructure representative of the weld metal in transverse section through NBS weldment IC. The microstructure appears to consist primarily of bainite. Etchant: two percent nital. X200

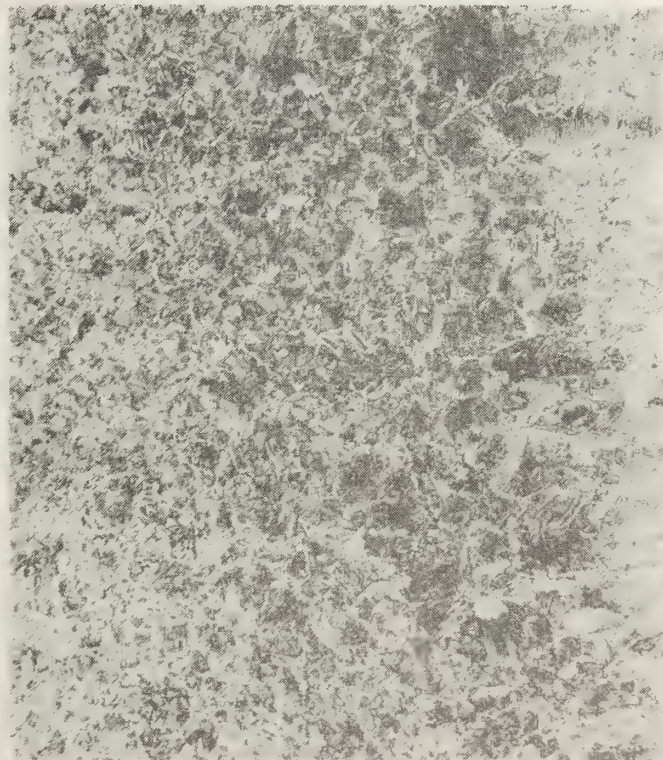
The transition region between the weld metal and the heat affected zone is shown in figure A7.4.1-4. Nothing unusual was observed at the transition. The microstructure within the heat affected zone is shown in figure A7.4.1-5. The microstructure consists of ferrite, primarily as a network in prior austenite grain boundaries, bainite, partially spheroidized carbides, and tempered martensite. Average hardness of the heat affected zone based on five measurements is 202 HK<sub>500</sub> (90.2 HRB) with a range of 196 to 206 HK<sub>500</sub> (89 to 91 HRB). Figure A7.4.1-6 shows the transition from the heat affected zone to the base material of the box beam. Hardness in this region averages 173 HK<sub>500</sub> (83 HRB) and the hardness range is 167 to 177 HK<sub>500</sub> (81 to 84 HRB).

Figure A7.4.1-4 Transition region from weld metal (right) to heat affected zone (left) in transverse section through NBS weldment IC. Etchant: two percent nital. X200

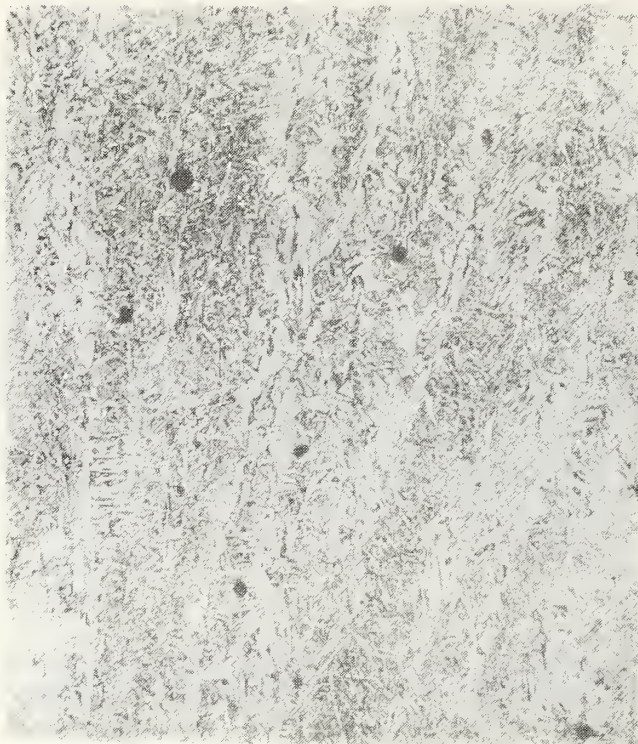
Representative regions of the weld metal from sections 1BM1 and 1BM2 are shown in figures A7.4.1-12 and A7.4.1-13, respectively. In both cases, the microstructure appears to consist of bainite. A number of inclusions are evident in section 1BM1. The average hardness of the weld in section 1BM1 (95 HRB) is slightly higher than in the weld of section 1BM2 (91 HRB) and the hardness range in the weld of section 1BM1 is greater.

Figure A7.4.1-12 Representative microstructure of the weld metal in transverse section 1BM1 through box beam 9U (NBS 1). The microstructure consists primarily of bainite. Some inclusions are evident. Etchant: two percent nital. X200

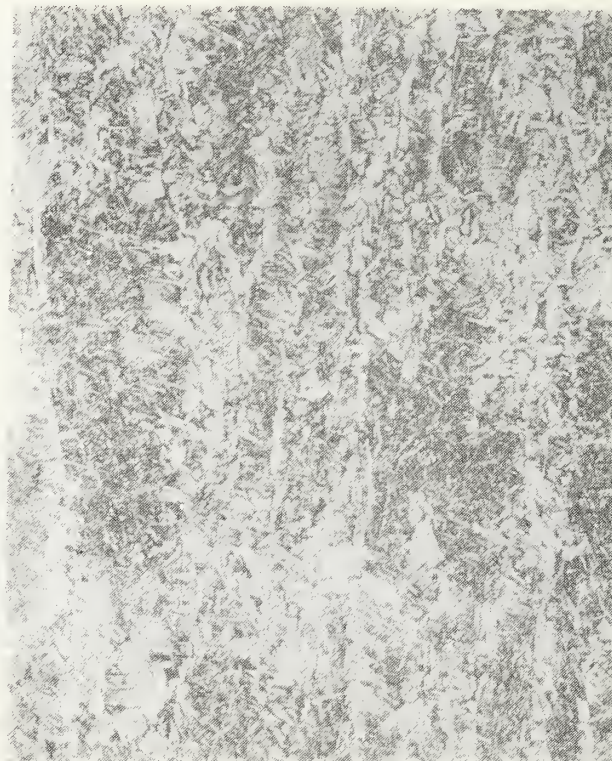
Figure A7.4.1-13 Representative microstructure of the weld metal in transverse section 1BM2 through box beam 9U (NBS 1). The microstructure consists primarily of bainite. Etchant: two percent nital. X200

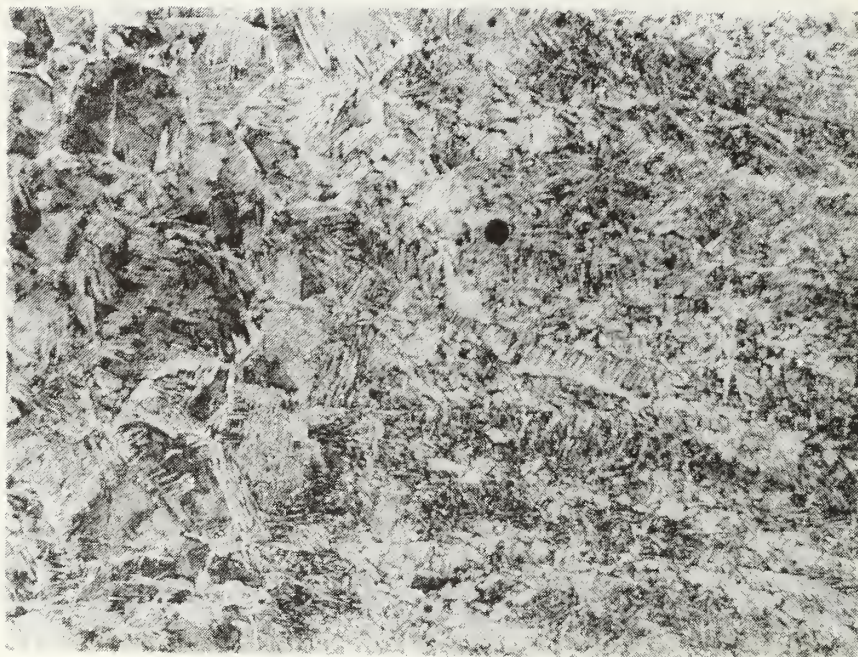
Hard patches were not observed in the transition region from weld to heat affected zone in section 1BM2. An area representative of this region in section 1BM2 is shown in figure A7.4.1-16.

Figure 7.4.1-16 Transition zone from weld metal (right) to heat affected zone (left) in section 1BM2. Some inclusions can be seen. Etchant: two percent nital. X200

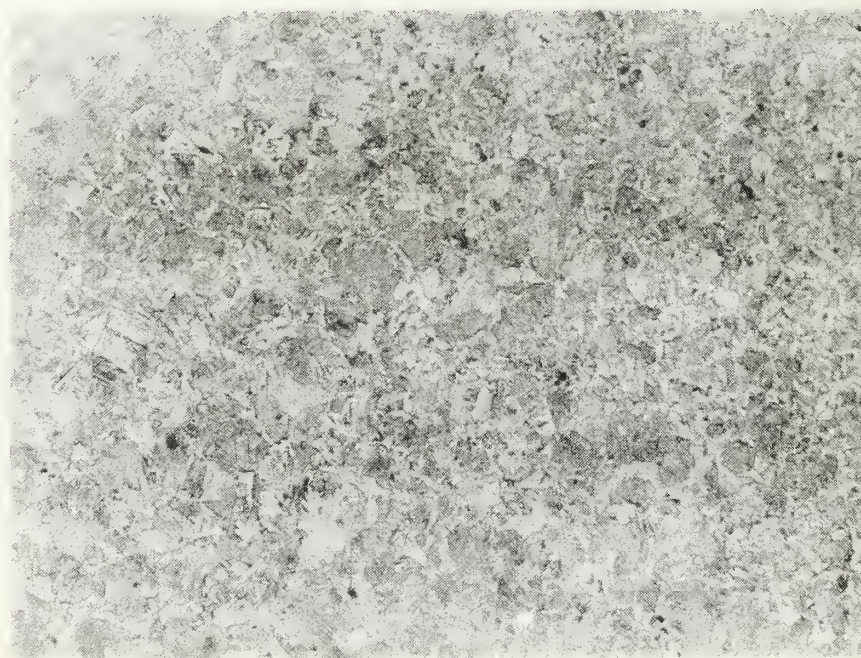
Regions representative of the heat affected zones (HAZ) of sections 1BM1 and 1BM2 are shown in figures A7.4.1-17 and A7.4.1-18, respectively. In both cases, the microstructure appears to consist of ferrite, both as a network in prior austenite grain boundaries and as needles, bainite, partially spheroidized carbides, and tempered martensite. Hardness of the heat affected zones in section 1BM1 is somewhat greater at the south channel than at the north. At both heat affected zones, hardness decreased with distance from the weld. Hardness values in the heat affected zones of section 1BM2 were similar for both zones.

Figure A7.4.1-17 Region representative of the heat affected zone in section 1BM1. The microstructure appears to consist of ferrite, both as a network in prior austenite grains and as needles, bainite, partially spheroidized carbides, and tempered martensite. Etchant: two percent nital. X200

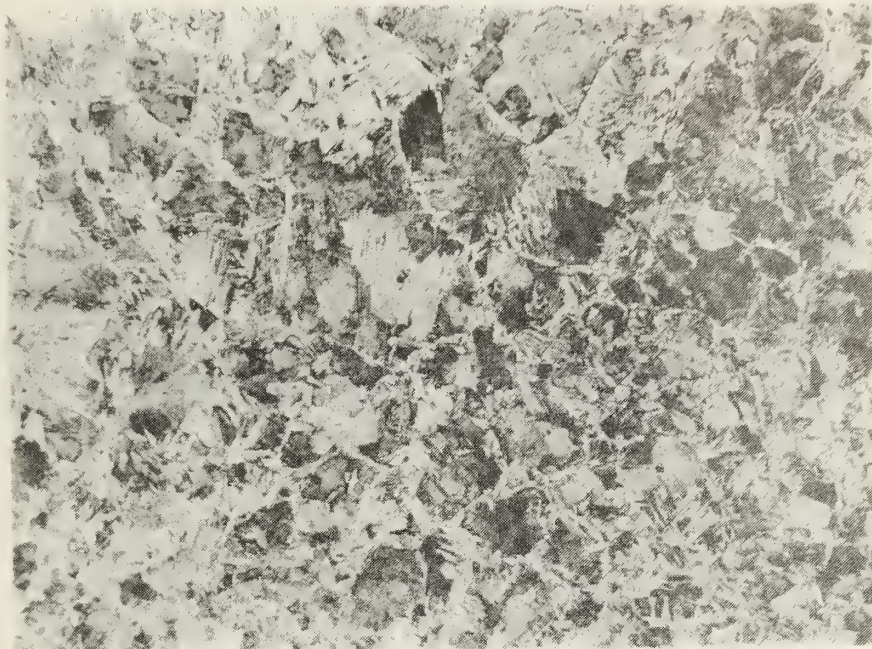
Figure 7.4.1-18 Region representative of the heat affected zone in section 1BM2. The microstructure appears to consist of ferrite, both as a network in prior austenite grains and as needles, bainite, partially spheroidized carbides, and tempered martensite. Etchant: two percent nital. X200

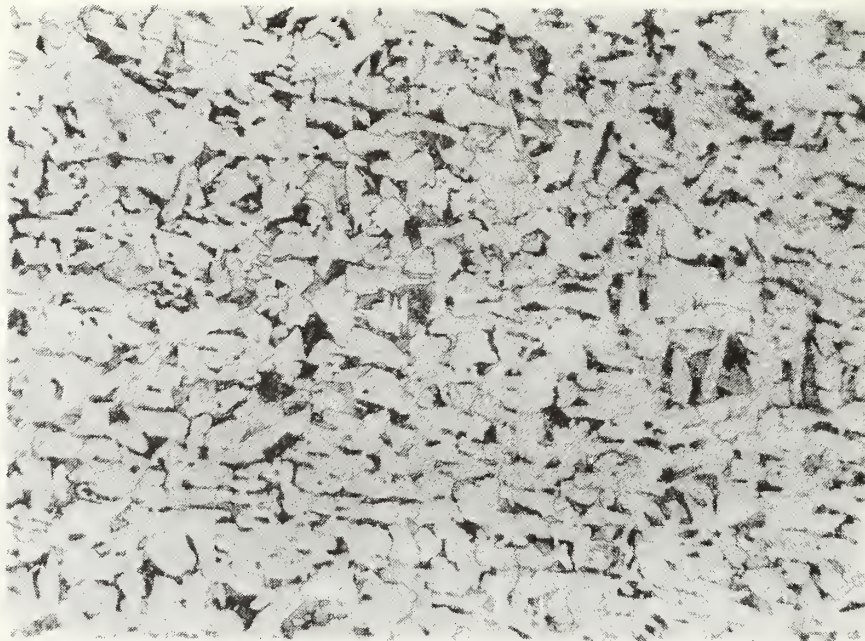
Base material from both channel pieces appeared similar. A region representative of section 1BM1 is shown in figure A7.4.1-20. The microstructure consists primarily of ferrite (light) and pearlite (dark) in a normalized condition. Rockwell B hardness measurements made on both sections indicated no significant differences in hardness between the two channel pieces used to fabricate the box beam. Regions of the channel adjacent to the heat affected zones and in the web region about 0.6 to 1 in (15 to 25 mm) from the bottom of the beam were harder than elsewhere with HRB hardness averaging 81.5. The hardness of the

Figure A7.4.1-20 Region representative of base channel material in section 1BM1. The microstructure consists primarily of ferrite (light) and pearlite (dark) in the normalized condition. Etchant: two percent nital. X200

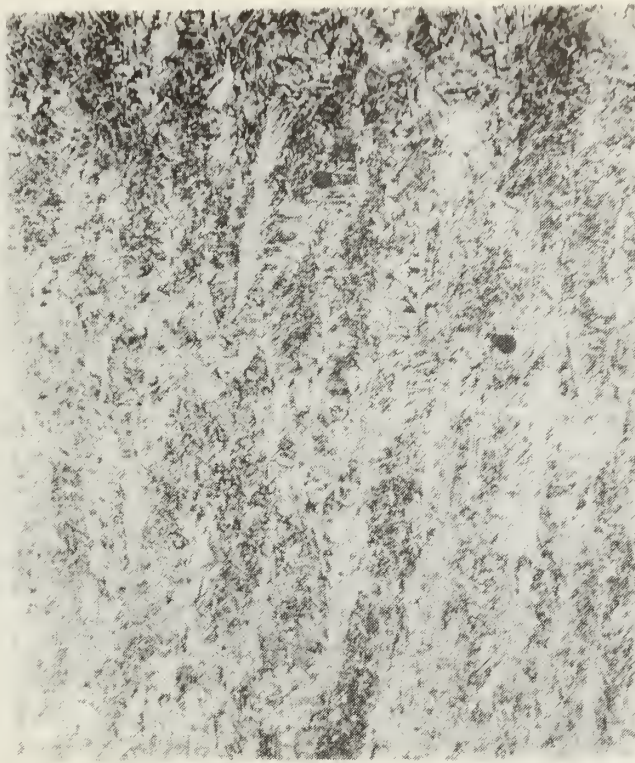
Regions representative of the weld metal in sections 2BM1 and 2BM2 are shown in figures A7.4.1-25 and A7.4.1-26, respectively. Overall, the microstructure in both cases appeared similar and consisted primarily of bainite. Inclusions are evident in both sections. The average hardness values for weld metal in the two sections do not differ significantly.

Figure A7.4.1-25 Representative microstructure of the weld metal in transverse section 2BM1 through box beam 8L (NBS 2). The microstructure appears to consist primarily of bainite. Some inclusions are evident. Etchant: two percent nital. X200

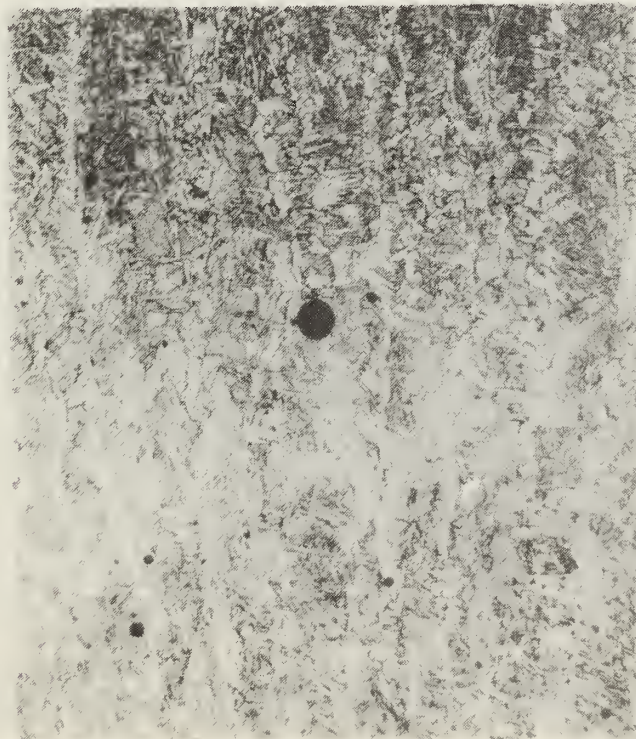
Figure A7.4.1-26 Representative microstructure of the weld metal in transverse section 2BM2 through box beam 8L (NBS 2). The microstructure appears to consist primarily of bainite. Some inclusions are evident. Etchant: two percent nital. X200

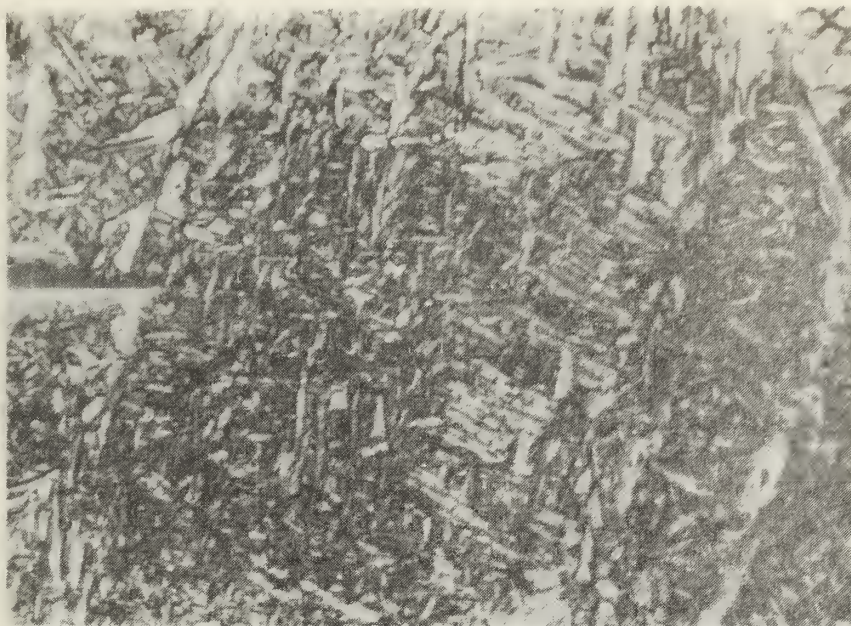
As was the case in section 1BM1 from box beam 9U, there were some hard spots at the transition from weld to the heat affected zone in section 2BM2 on the south side. The transition in section 2BM2 is shown in figure A7.4.1-28 at 200 magnifications. One of the hard regions is shown at much higher magnification (X1200) in figure A7.4.1-29. The microstructure of this region appears to be tempered martensite. The highest hardness value obtained in this region was 298 HK<sub>500</sub> which is approximately equivalent to 28 Rockwell C. Away from the hard regions, hardness averaged 247 HK<sub>500</sub> (99 HRB).

Figure A7.4.1-29 Region of the transition zone from weld metal to the heat affected zone in section 2BM2. This region is one of the hard areas. The microstructure appears to consist of tempered martensite. Part of a hardness test impression can be seen at the left center. Etchant: two percent nital. X1200

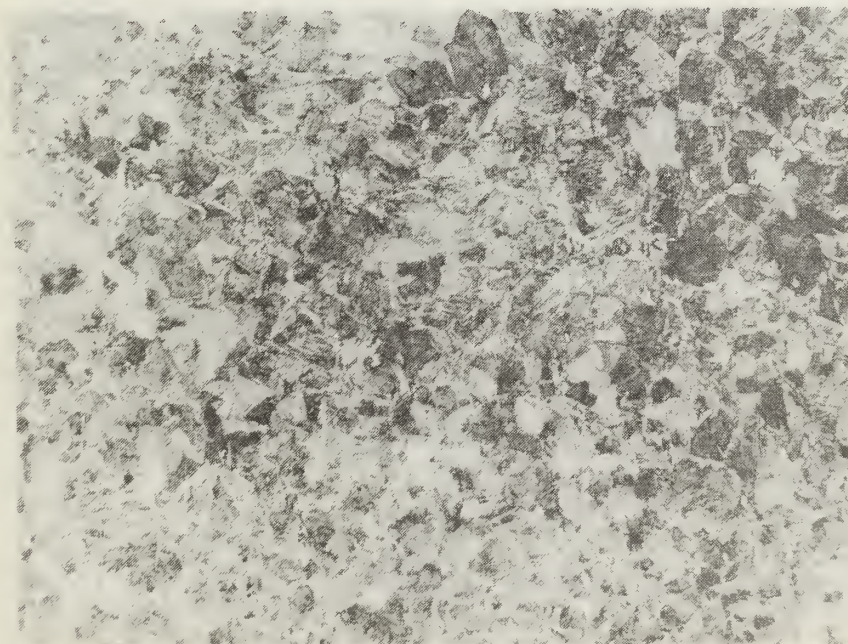
In the heat affected zones, the microstructure was similar in both sections 2BM1 and 2BM2. A representative region from section 2BM1 is shown in figure A7.4.1-30. The microstructure appears to consist of ferrite, both as a network in prior austenite grain boundaries and as needles, bainite, partially spheroidized carbides and tempered martensite. Hardness was 5 to 6 HRB points lower for the heat affected zones in section 2BM2 than in the weld metal. In section 2BM1, hardness was similar for both weld metal and the heat affected zone.

Figure A7.4.1-30 Representative microstructure of the heat affected zone in section 2BM1. The microstructure appears to consist of ferrite, both as a network in prior austenite grain boundaries and as needles, bainite, partially spheroidized carbides, and tempered martensite. Etchant: two percent nital. X200

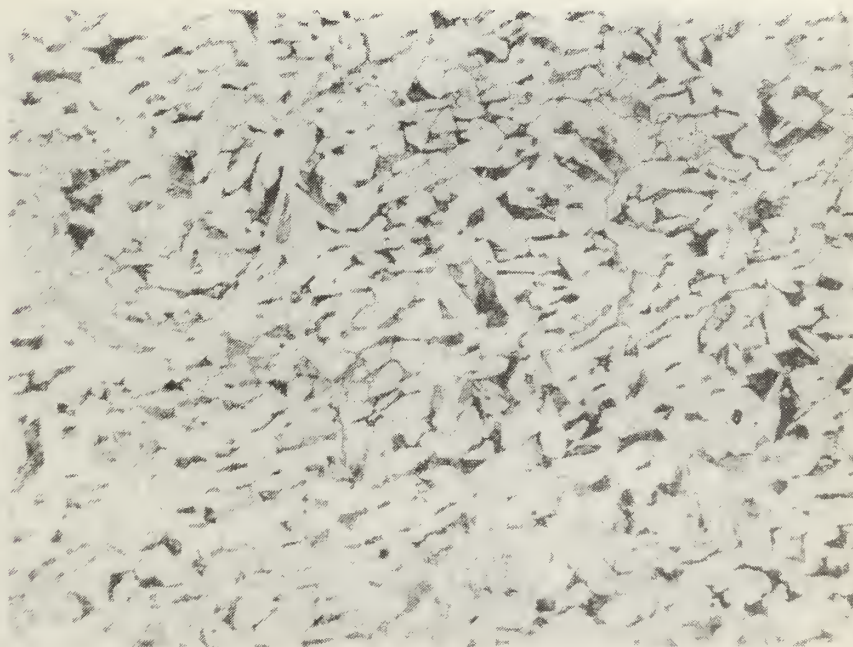
The base material of both channel pieces of the box beam appeared similar in microstructure in both sections 3BM1 and 3BM2. In both cases, the microstructure consists of ferrite and pearlite in a normalized condition. A region representative of the channel material is shown in figure A7.4.1-42. Hardness of both channels was also similar.

Figure A7.4.1-42 Representative region of base channel material in section 3BM1. The microstructure consists of ferrite (light) and pearlite (dark) in the normalized condition.  
Etchant: two percent nital. X200

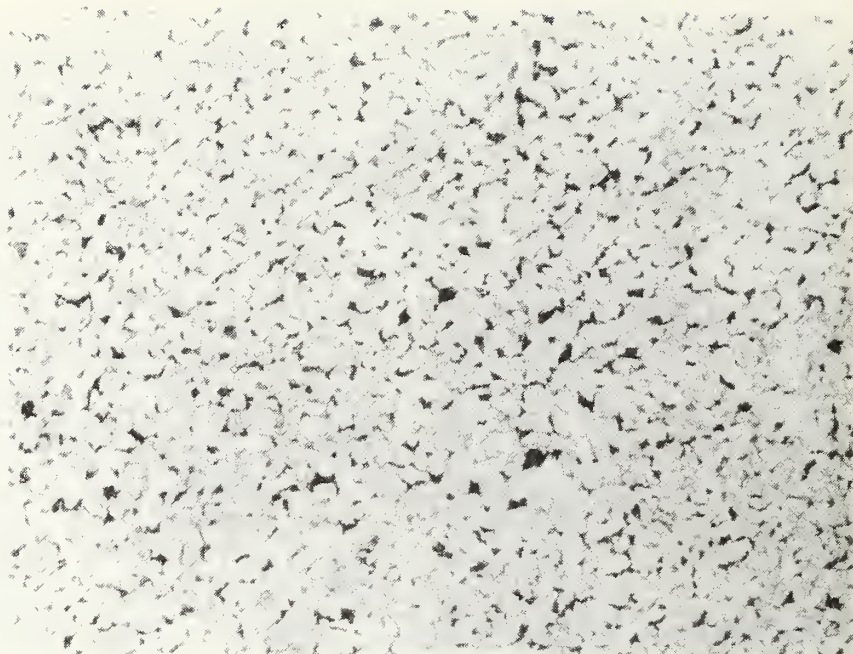
Transverse and longitudinal sections from each of the walkway hanger rod segments obtained from the debris (NBS 5A and 5B) were examined metallographically. The locations of these sections in the hanger rods are shown in figure A7.3.3-1. A representative region showing the etched microstructure of the transverse section from hanger rod NBS 5A is shown in figure A7.4.2-1. The

microstructure consists of ferrite (light) and pearlite (dark) in a reasonably fine grained (ASTM grain size 9) normalized structure.

Figure A7.4.2-1 Transverse section through hanger rod NBS 5A showing the representative microstructure. The microstructure consists of relatively fine grained ferrite (light) and pearlite (dark) in a normalized condition. Etchant: two percent nital. X100

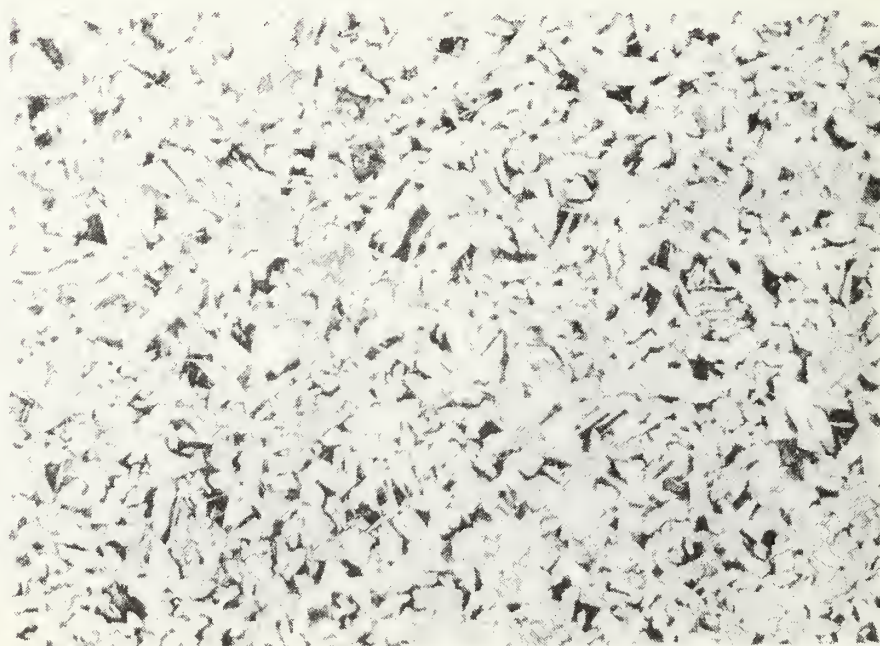
The representative microstructure of the transverse section from hanger rod NBS 5B is shown in figure A7.4.2-2. The microstructure again consists of ferrite (light) and pearlite (dark) in the normalized condition. This microstructure is coarser (ASTM grain size 7-1/2 to 8) than that of hanger rod NBS 5A, and there appears to be more pearlite present than in hanger rod NBS 5A.

Figure A7.4.2-2 Transverse section through hanger rod NBS 5B showing the representative microstructure. The microstructure consists of ferrite (light) and pearlite (dark) in a normalized condition. Etchant: two percent nital. X100

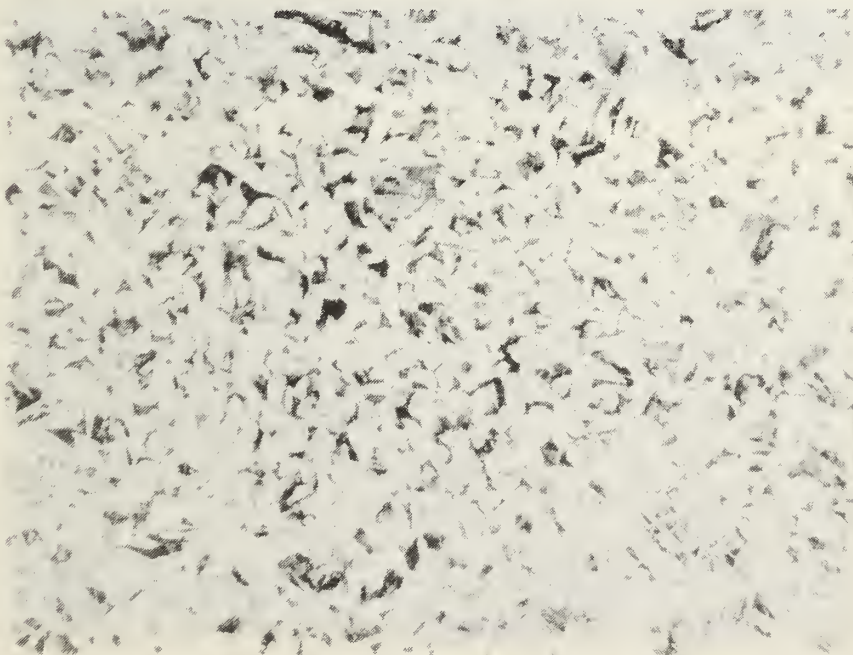
Longitudinal sections through each hanger rod segment revealed the material of both to be fully normalized with equiaxed grains. Regions representative of the longitudinal microstructures are shown in figure A7.4.2-3 for rod segment NBS 5A and in figure A7.4.2-4 for rod segment NBS 5B.

Figure A7.4.2-4 Longitudinal section through hanger rod NBS 5B showing the normalized microstructure consisting of ferrite and pearlite. Etchant: two percent nital. X100

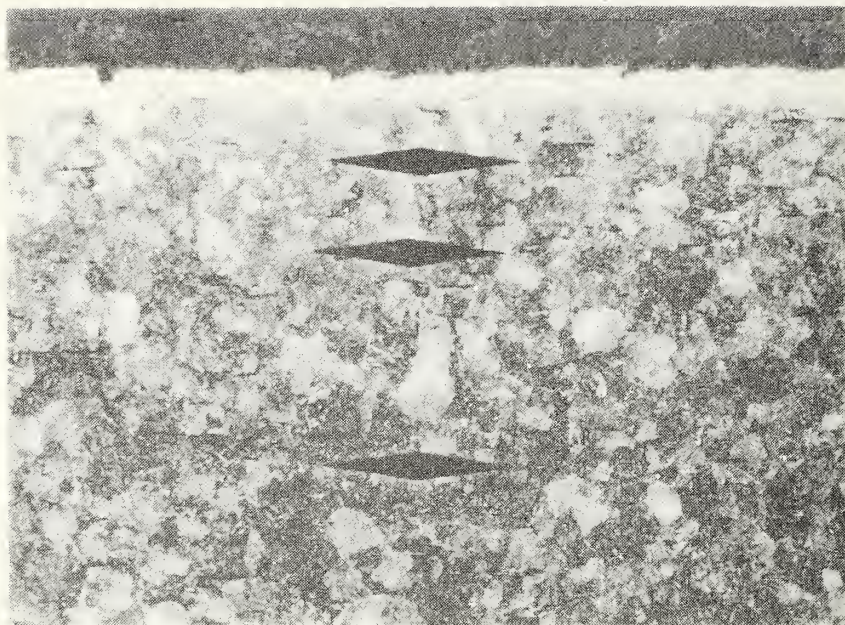
Knoop microhardness measurements at a load of 500 grams force (HK<sub>500</sub>) were made on a cross section through a washer from the walkway debris at location 9MW after it had been used in an NBS full length test on box beam 9M. During the test, the washer fractured into five pieces. A microhardness traverse was made through the thickness of the washer on the section examined. The washer thickness was approximately 0.075 in (1.80 mm). Average hardness from 16 measurements across the section was 459 HK<sub>500</sub> which is approximately equivalent to 44.3 HRC and the hardness range was 422 to 514 HK<sub>500</sub> (41.5 to 48.5 HRC). The highest values were near the center of the section and the lowest values were near the surface of the washer. The microstructure of the washer from location 9MW is shown in figure A7.4.3-1. There is a very small apparent decarburized

layer at the surface (light area at the top in the figure). Tempered martensite is the primary constituent of the microstructure.

Figure A7.4.3-1 Microstructure of washer from location 9MW in the walkway debris. The thin, light layer at the surface (horizontal near the top in the figure) is the decarburized layer at the washer surface. The microstructure consists primarily of tempered martensite. Etchant: Picral. X200

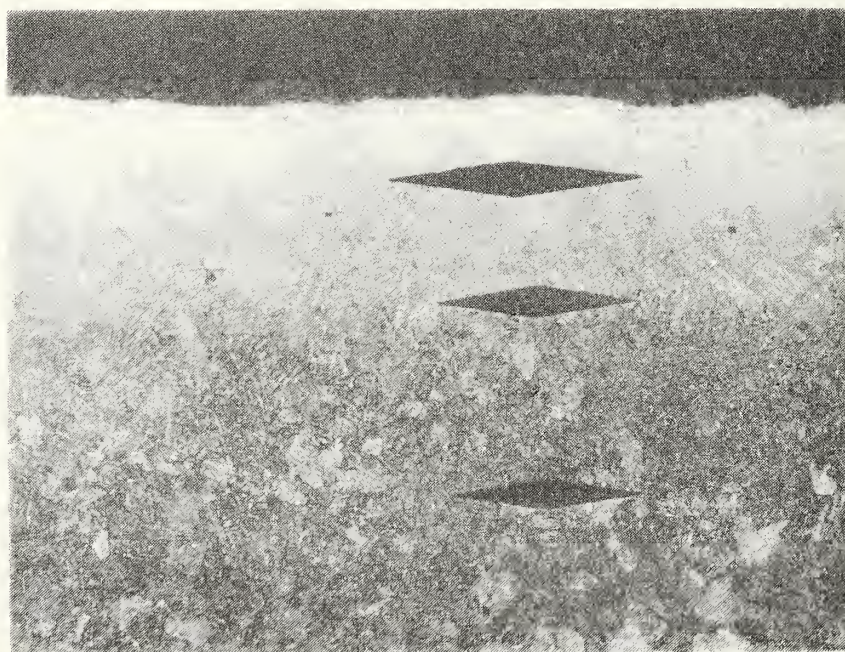
A similar microhardness traverse on a section through one of the NBS hard washers was made. Hardness values in this section, excluding the decarburized layer at the surface, averaged 431 HK<sub>500</sub> (42.5 HRC) and ranged from 401 to 422 HK<sub>500</sub> (40 to 43.5 HRC). Measured hardness in the decarburized layer was as low as 247 HK<sub>500</sub> (99 HRB). The microstructure of the NBS hard washer is shown in figure A7.4.3-2. The decarburized layer at the surface appears light in the figure. Tempered martensite is the primary constituent in the microstructure.

Figure A7.4.3-2 Microstructure of NBS hard washer. The light layer at the surface (horizontal near the top in the figure) is decarburized. The microstructure consists primarily of tempered martensite. Etchant: Picral. X200
